ENGINEERING REPORT
RAPPORT TECHNIQUE

LP 087/2005

Fuel System Components Examination
VariEze Homebuilt, N914VE
20 July 2005

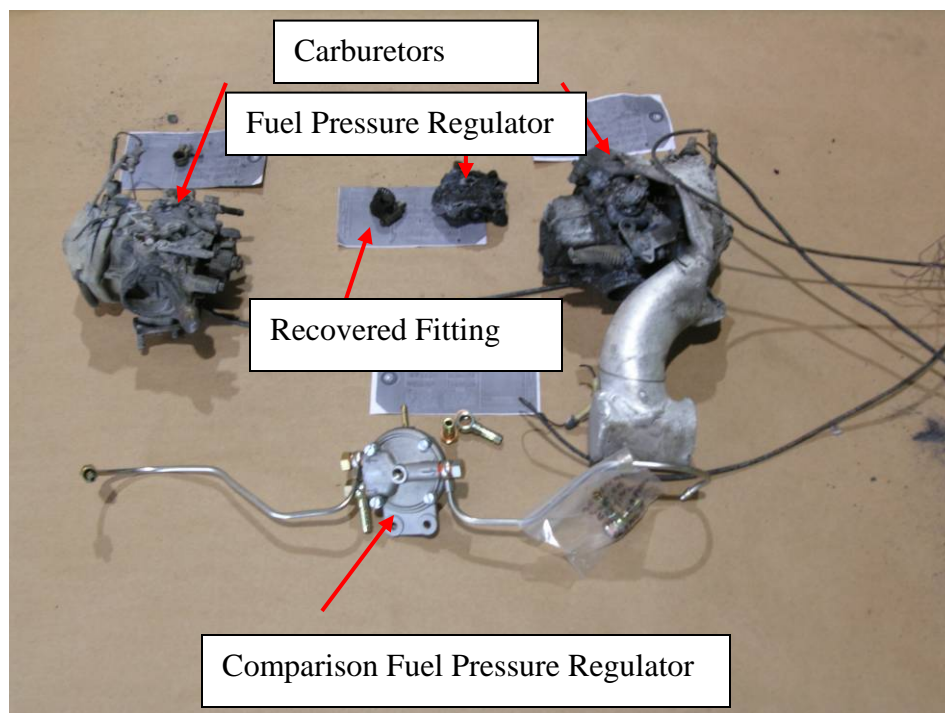
- 2.1 The two carburetors, fuel pressure regulator, recovered fitting and comparison fuel pressure regulator are shown as received in Figure 1. Examination of the components revealed that they had been exposed to excessive heat. The two carburetors and fuel pressure regulator showed evidence of melting. Both are manufactured of an aluminum alloy and the melting point of these alloys is 538 to 593 degrees Celsius (1000 to 1100 degrees Fahrenheit) (refer to Figures 2 and 3). The two carburetors and fuel pressure regulator showed no signs of a failure other than the heat and impact damage.
- 2.2 The recovered fitting which was found on the wreckage trail still had the rubber hose and clamp attached (refer to Figure 4). The fracture surface was damaged from the fire. Examination did not show any signs of a progressive failure (refer to Figure 5).

Figure 1 - Photograph showing the two carburetors, fuel pressure regulator, banjo fitting and comparison fuel pressure regulator as received.

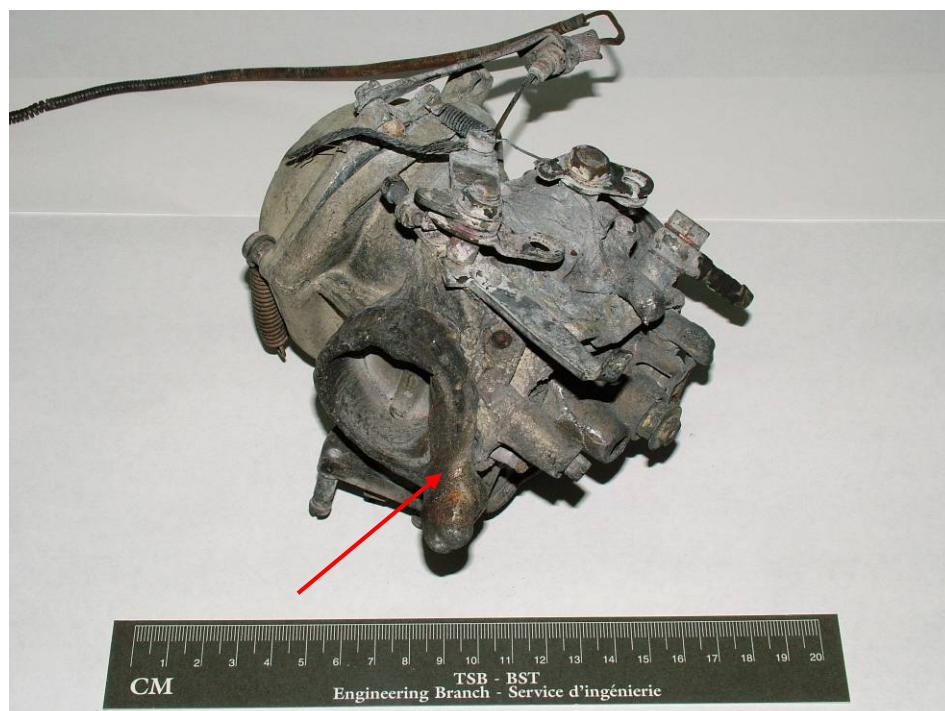
- 3.2 The two carburetors and fuel pressure regulator had areas which were melted and deformed indicating that they had been exposed to excessive heat during the accident. Both are manufactured of an aluminum alloy which has a melting point of 538 to 593 degrees Celsius. No failures were observed that might have caused them to be a contributing factor in the fire that was observed to have occurred prior to the aircraft impacting the ground.

Figure 2 - Photograph showing one of the carburetors. Arrow points to the heat deformed area.

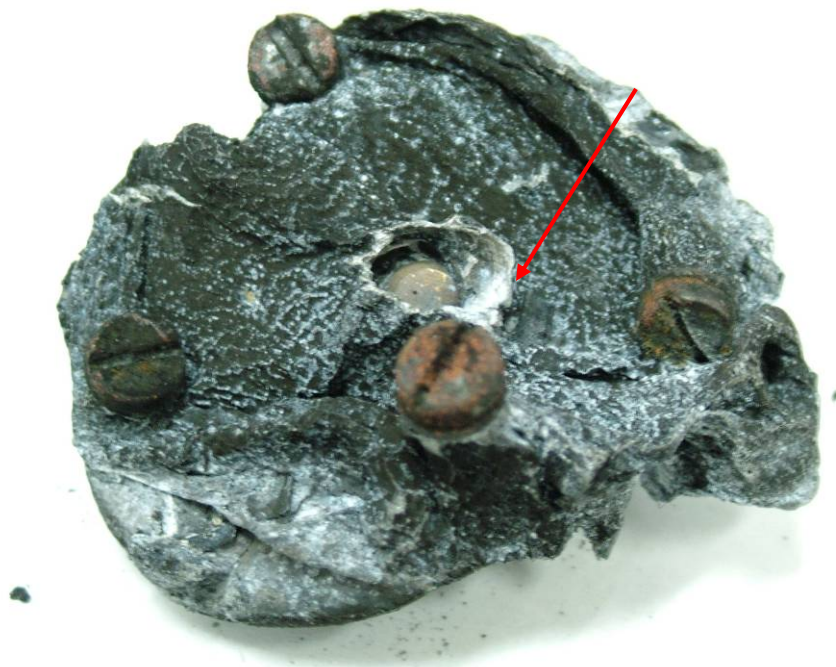
Figure 3 - Photograph showing the excessive heat damage to the fuel pressure regulator. Arrow points to area on the regulator where the aluminum has drooped.

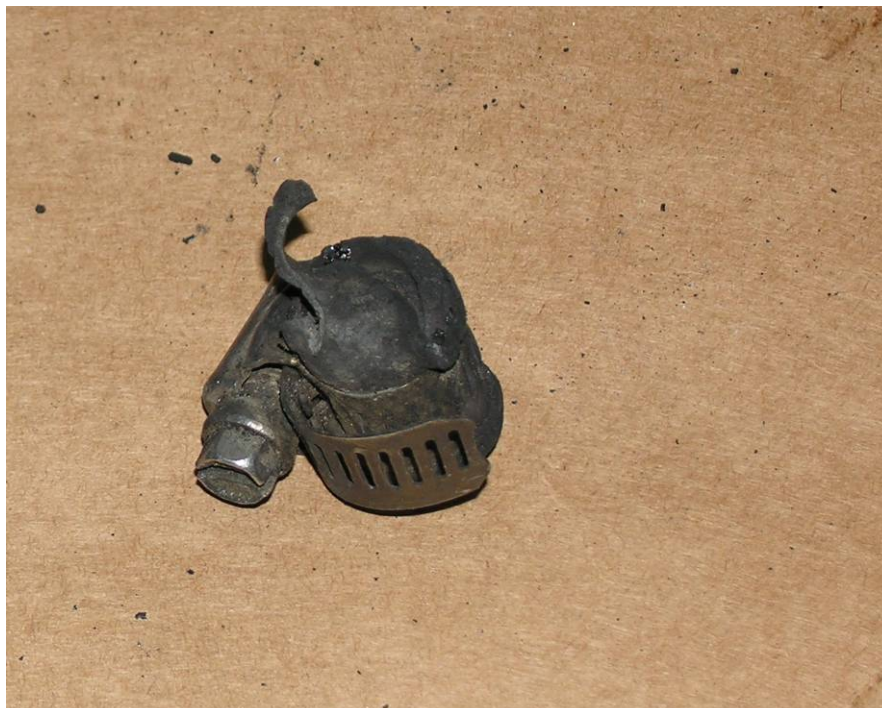
Figure 4 - Photograph showing the recovered fitting with the hose and clamp still attached.

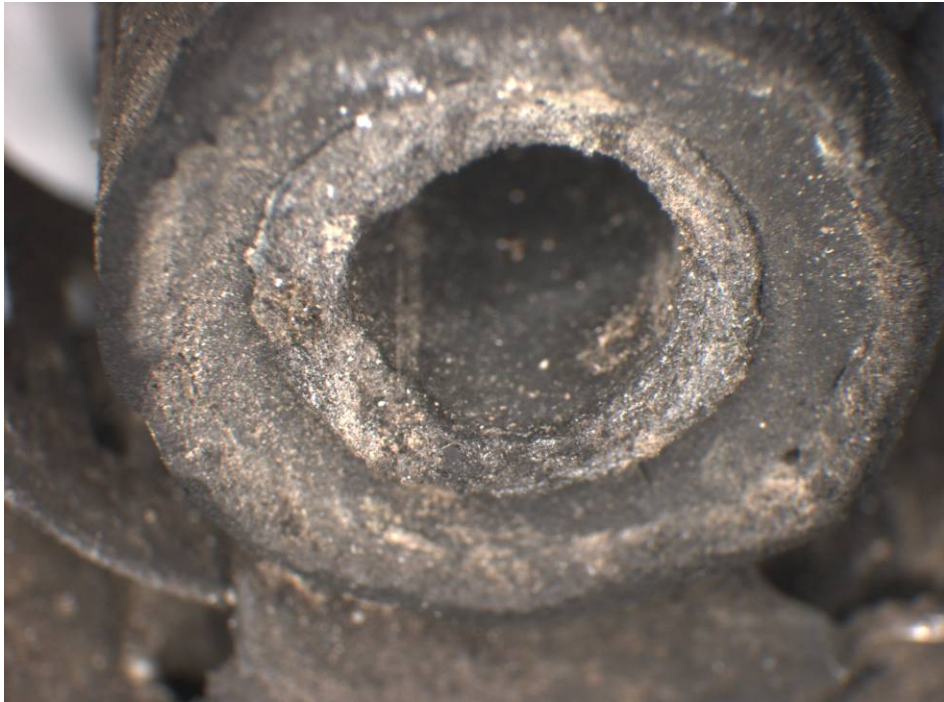
Figure 5 - Photograph showing the fracture surface on the recovered fitting. Rubber hose and clamp are still attached.

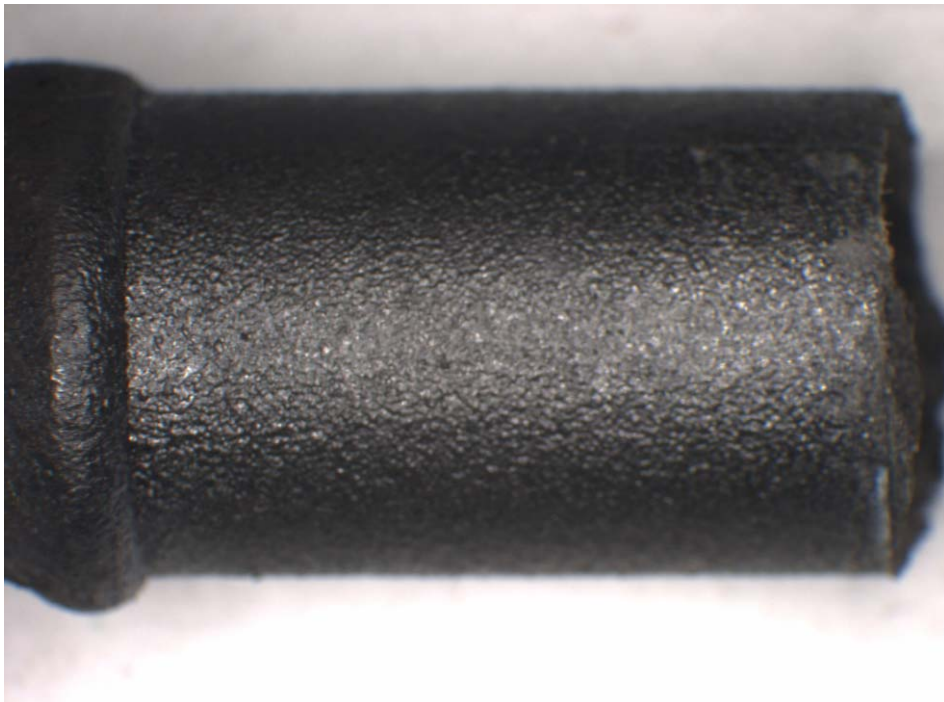
The hose and clamp were removed exposing the remaining section of fitting. The hose connection area had no barbs present in this area (refer to Figure 6). A saw cut was performed on the fitting revealing that it was made of plastic (refer to Figure 11). The banjo fitting from the comparison fuel pressure regulator is made from steel and the hose connection area has barbs (refer to Figure 7). The two carburetors also have banjo fittings which are slightly smaller and they also have barbs on the hose connection area (refer to Figure 8).

Figure 6 - Photograph showing the hose connection area of the recovered fitting, note there are no barbs on the hose connection area.

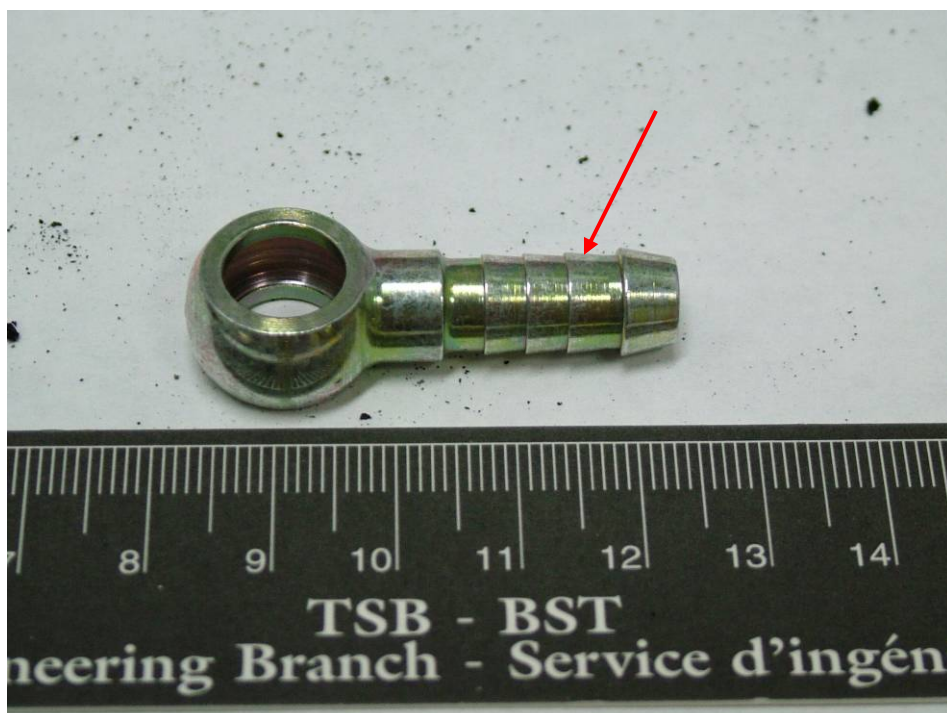
Figure 7 - Photograph showing a banjo fitting from the comparison fuel pressure regulator. Note the barbs on the hose connection area (arrow)

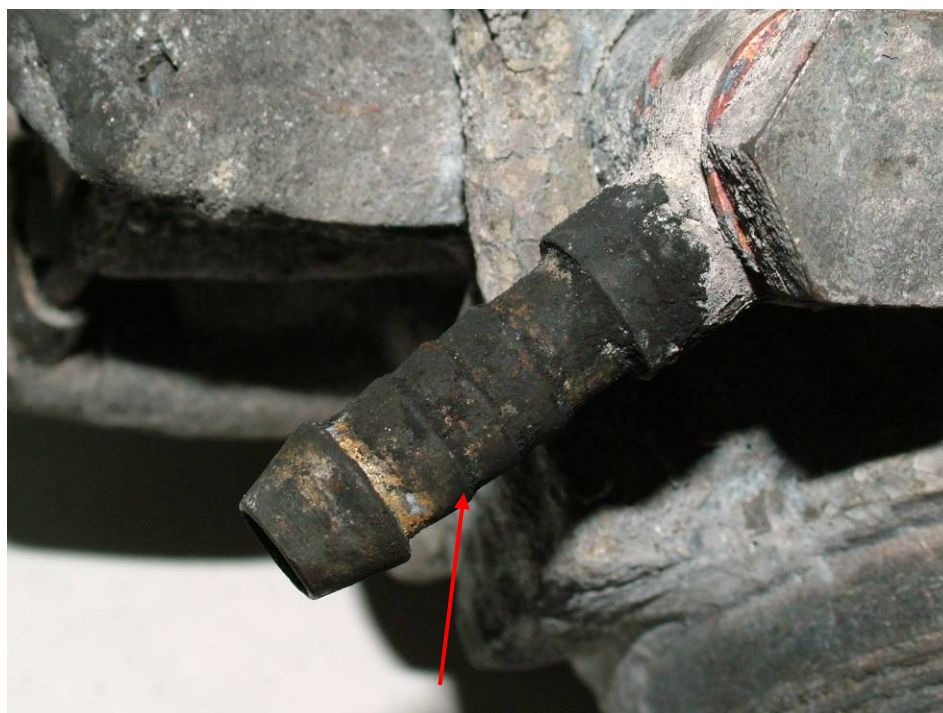
Figure 8 - Photograph showing a banjo fitting from the carburetor. Note the barbs on the hose connection surface (arrow).

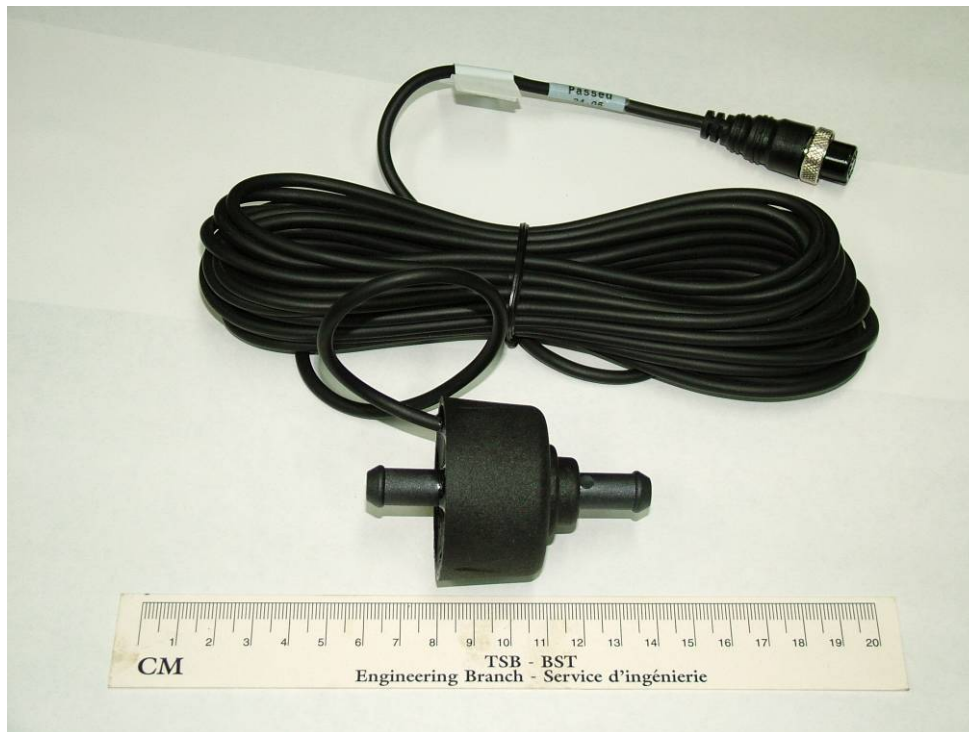
Figure 9 - Photograph showing the new fuel transducer obtained from NAVMAN.

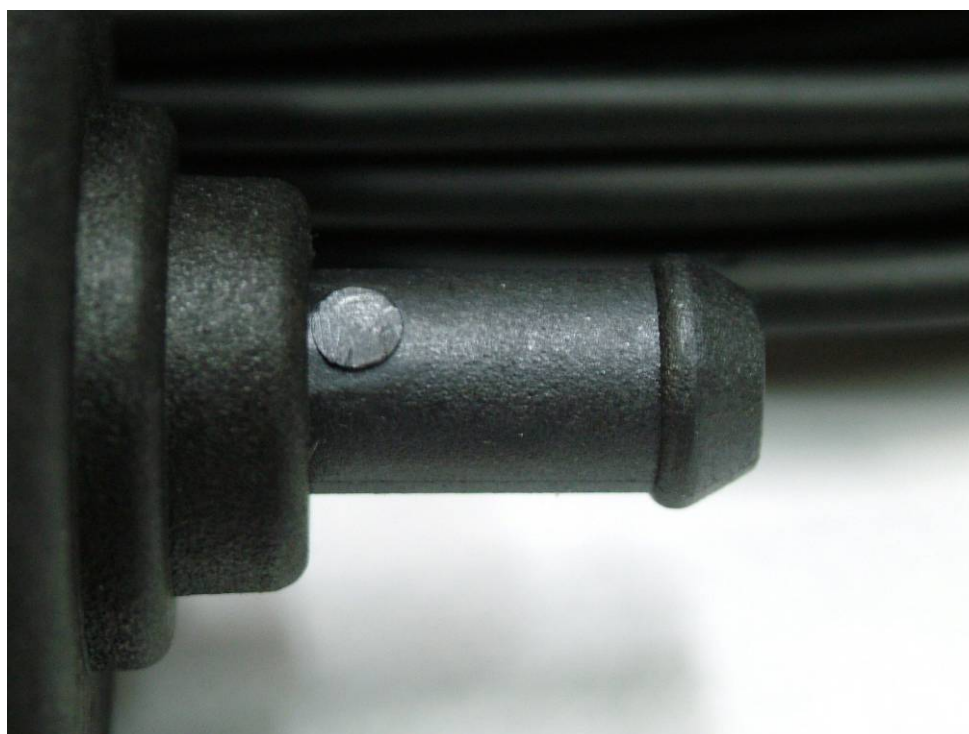
Figure 10 - Close-up photograph showing the hose connection area on the inlet side of the new fuel transducer.

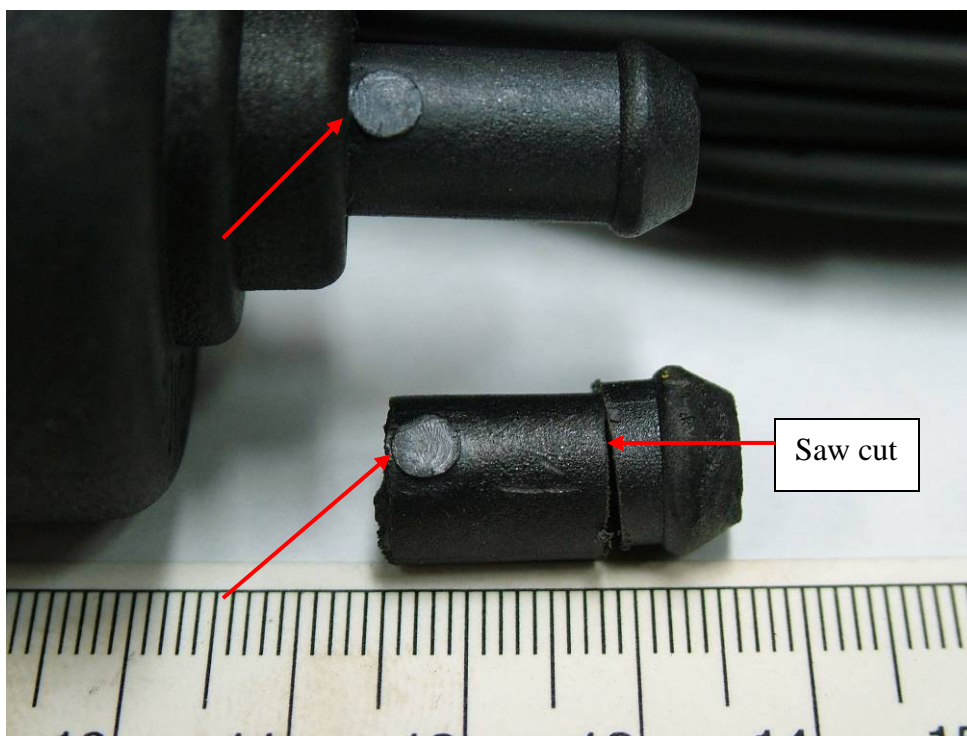
- 3.1 The visual comparison and dimensional results of the recovered fitting and inlet side portion of the new fuel transducer reveal that the recovered fitting is most likely the inlet side of a fuel transducer from a NAVMAN 2100 Fuel Flow Monitor System. Since only a small part of the fuel transducer was recovered, it is not known if it was a factor in the pre-crash fire. The NAVMAN system was not intended or designed for use in aircraft. It has a published maximum operating temperature of 50 degrees Celsius and a reported component failure at a temperature of 509 degrees Celsius. The engine compartment on the subject aircraft could see temperatures of several hundred degrees Celsius during normal operation. The recovered fuel pressure regulator and carburetor had areas of melting, which would occur at a temperature range of 538 to 593 degrees Celsius. If the fuel transducer from the NAVMAN 2100 System was mounted in the engine compartment area it could have been exposed to temperatures that exceeded its maximum designed environmental temperature range.

Figure 11 - Photograph showing the recovered fitting (bottom) with the hose connection area from the inlet side of the new fuel transducer. Note both have the same circular flat spot (arrows).

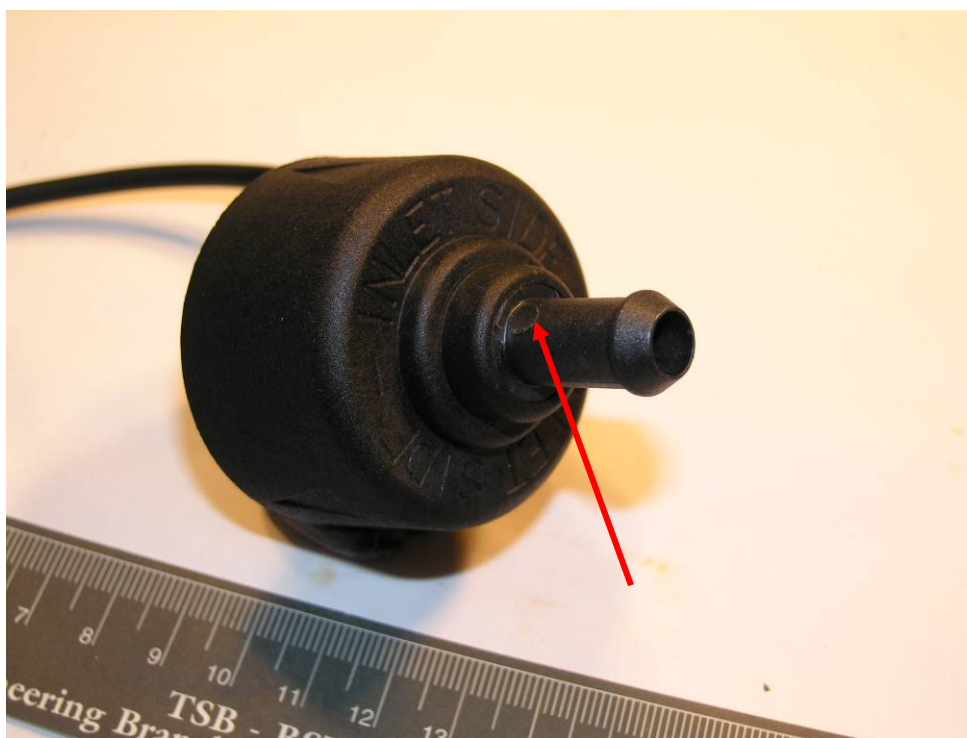
Figure 12 - Photograph showing the inlet side of the new fuel transducer. Arrow points to the circular flat spot on the hose connection area.
