PROP LOSS – DESERT CENTER

Emergency Landing in a COZY MKIV

Marc J. Zeitlin

July 26th, 2007

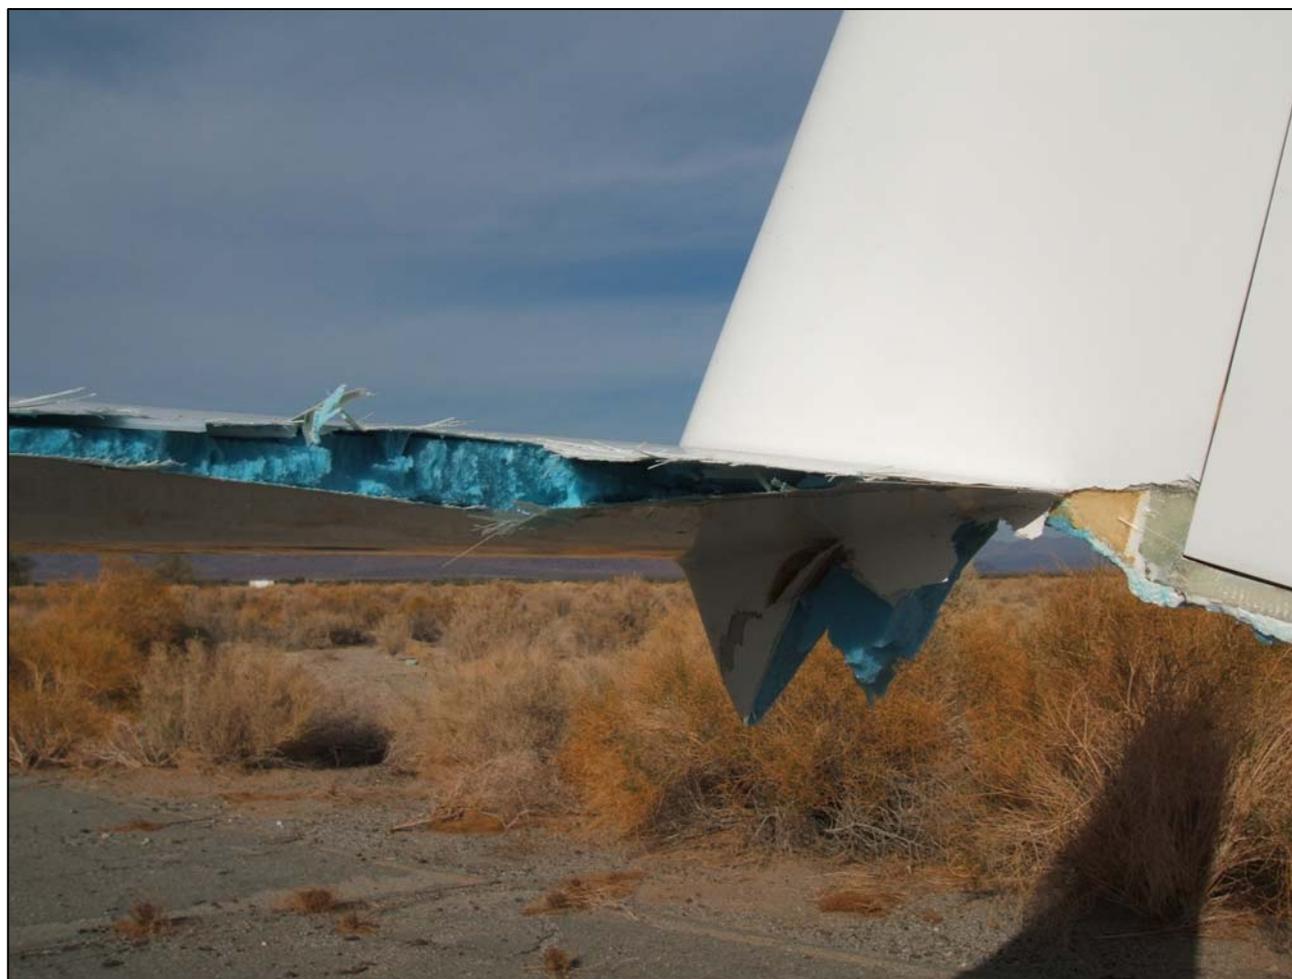
Slide #11

- Emotional release after landing
- Get out, call ATC, inform of safe landing, no damage, no injuries
- Talk to Deanie about what happened
- Take a look at prop extension and cowl area – notice that right lower winglet is missing, as is part of trailing edge of wing
- Discuss damage to aircraft with Deanie
- Call Bill Seibold – ask for retrieval in his COZY III
- Push aircraft 3,000 ft. down taxiway to parking area and tie down
- Eat, drink, relax

Damage Picture

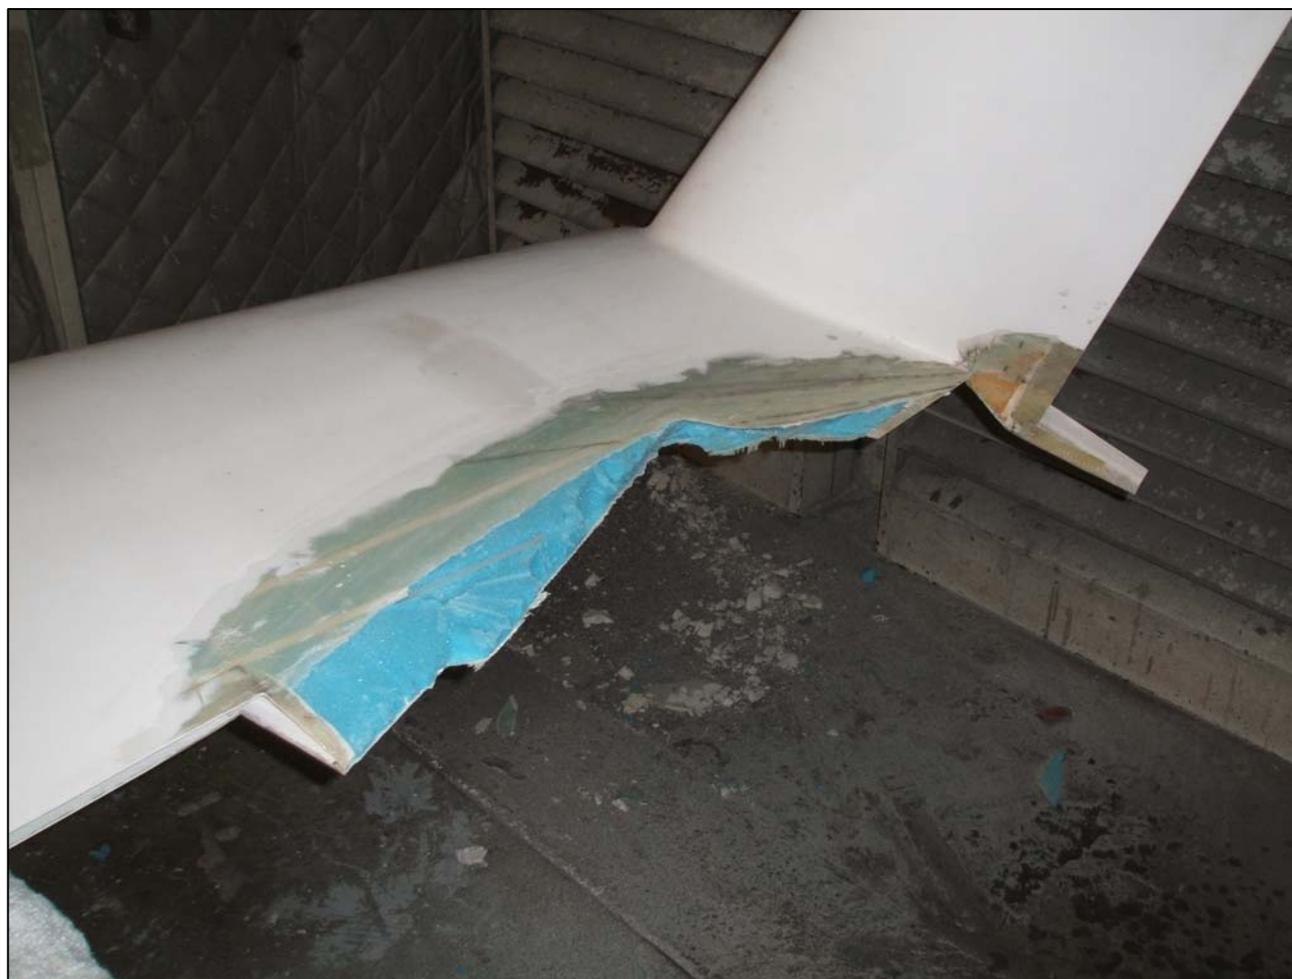
Slide #12

Damage Picture

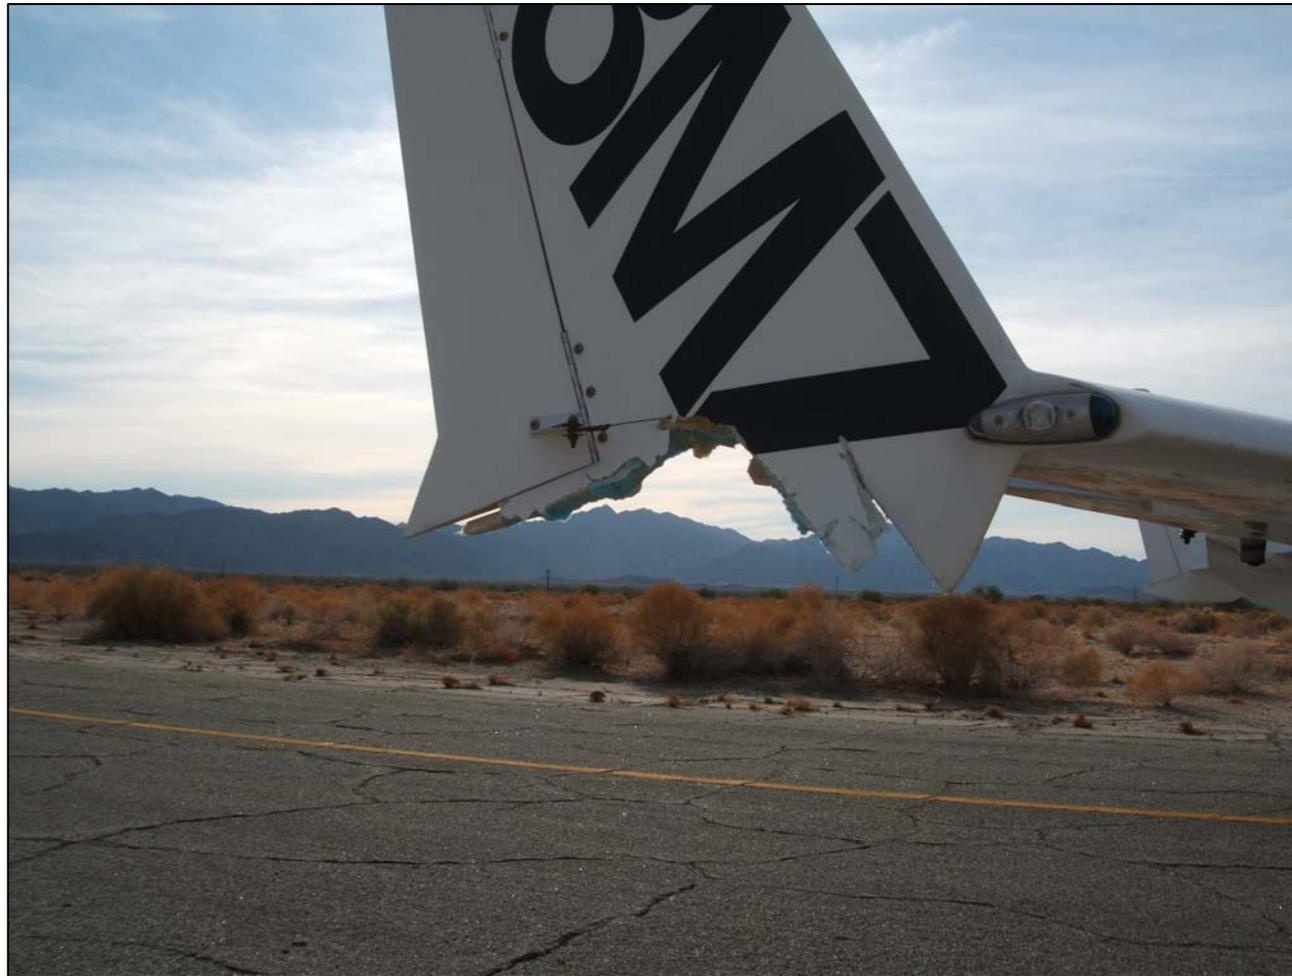
Slide #13

Damage Picture

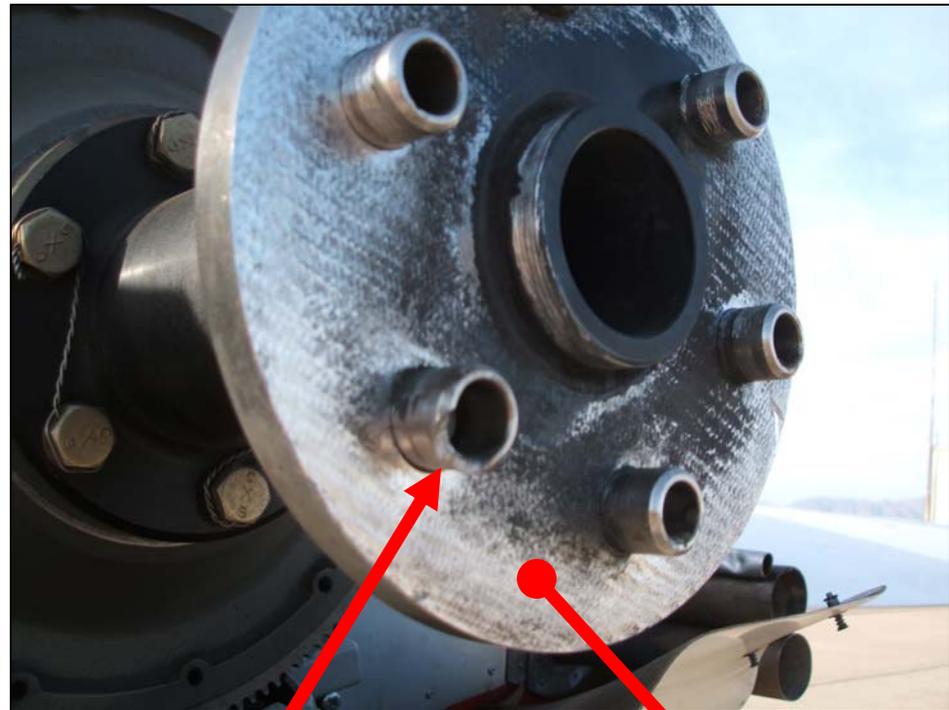
- Incorrect torque on prop bolts
- Low compression on wood prop
- Motion between prop and extension – possible contribution from spinner backplate softening
- Fretting of prop/extension mating surfaces
- Fatigue of bolts from relative motion
- Bang!

Bent lug

Fretted Surface

- With current technology, need constant torque checking/adjustment of wood propeller bolts – generally every 25 hours, or after major humidity change
- Poor torque checking technique – only checked static torque
- Far too infrequent torque checks
- Need new design for wood prop hubs, or new method for tensioning prop bolts – folks have lived with this design defect for far too long, considering new materials that exist
